⑥ Mechanized Rifle Troop (M113)

⑦ MONTHLY TEST REPORT, NUMBER 2,

1-31 March 1963

SUBJECT: Monthly Test Report Number 2 -- Mechanized Rifle Troop (M113)
(1-31 March 1963) (U)

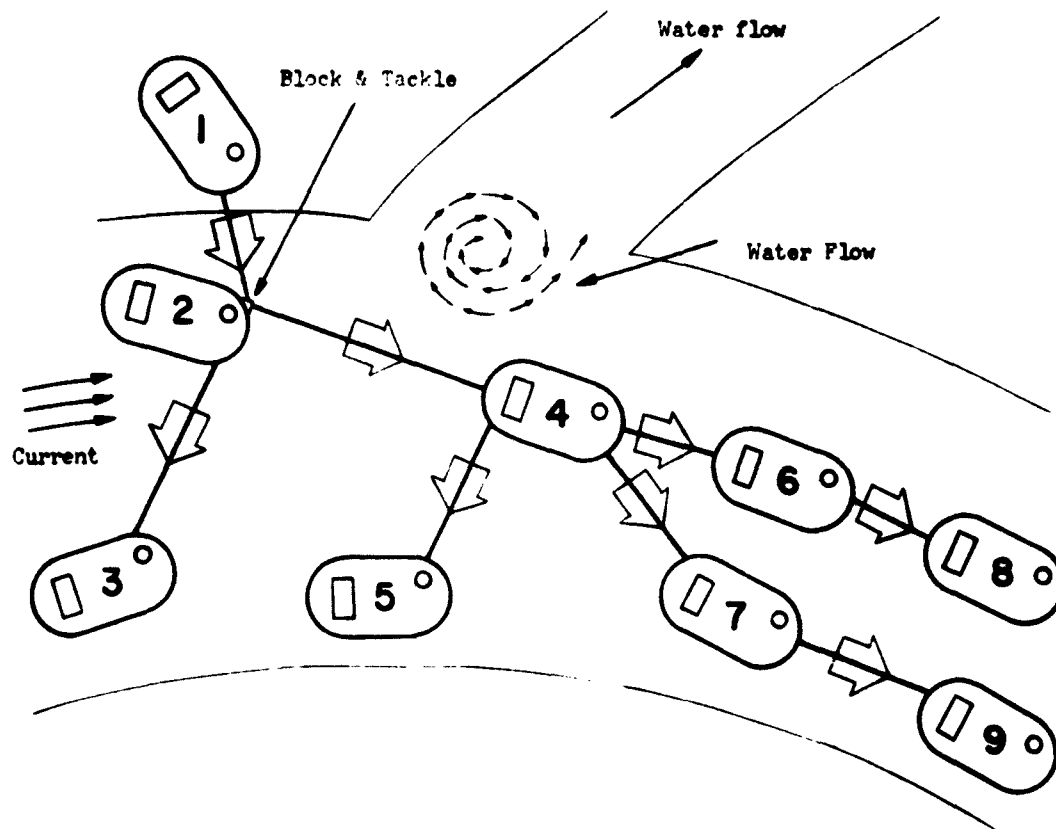
RECOVERY OF M113, 28 MARCH 1963

Vehicle mired in mud is number 1.

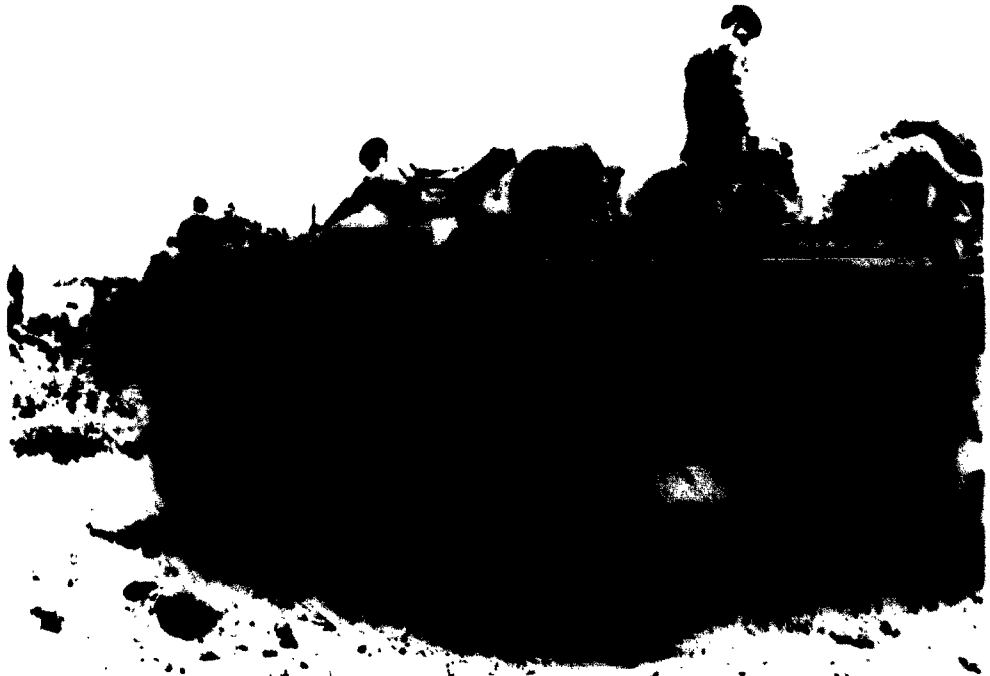
Photo 2

Troop stops by first canal (left). Pioneer squad (attached) prepares to place balk. System for securing balk to carriers was developed previous day.
